Report 15084

**RESULTS OF THE PHASE II LONG-TERM
ENVIRONMENTAL STORAGE TEST PROGRAM FOR
THE RJ43-MA-11 RAMJET ENGINE
OCTOBER 1960 THROUGH OCTOBER 1963**

Contract AF 33(657)-7770

Model RJ43-MA-11

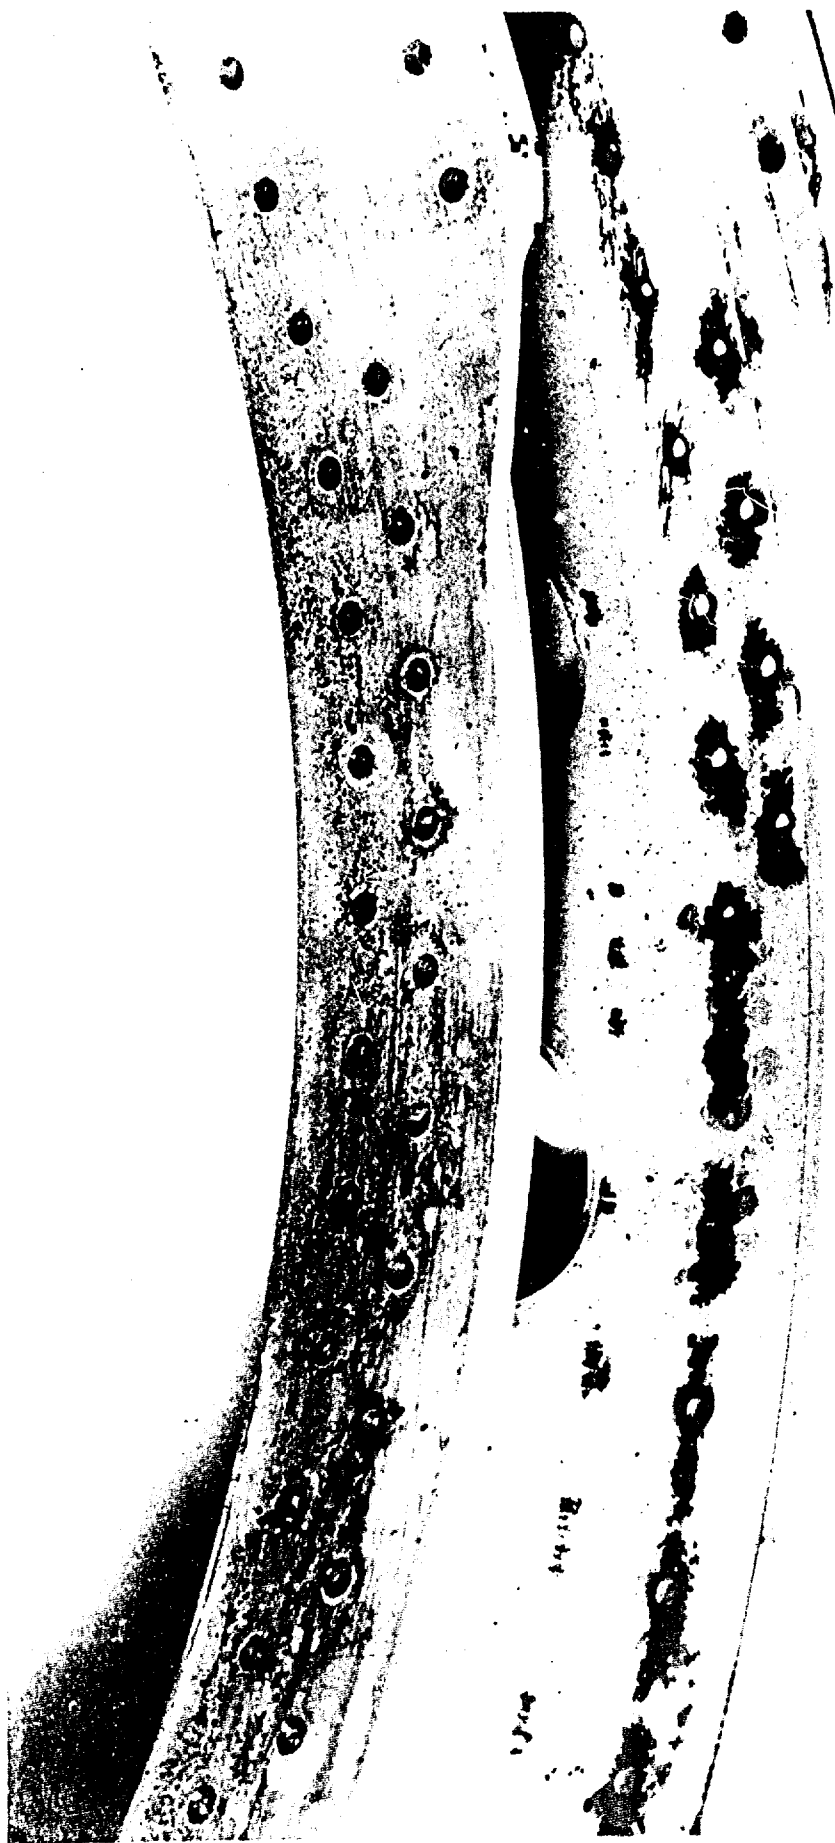
FIGURE 12 - Station 75.75 Ring Frame From RJ43-MA-11 Engine Serial MA-EI0011-1 Showing Corrosion, Due to Deburring and No Subsequent Protective Touch-up, Which Occurred Around Attach Holes During the Accelerated Storage Phase of the RJ43-MA-11 Phase II Long-Term Storage Test.

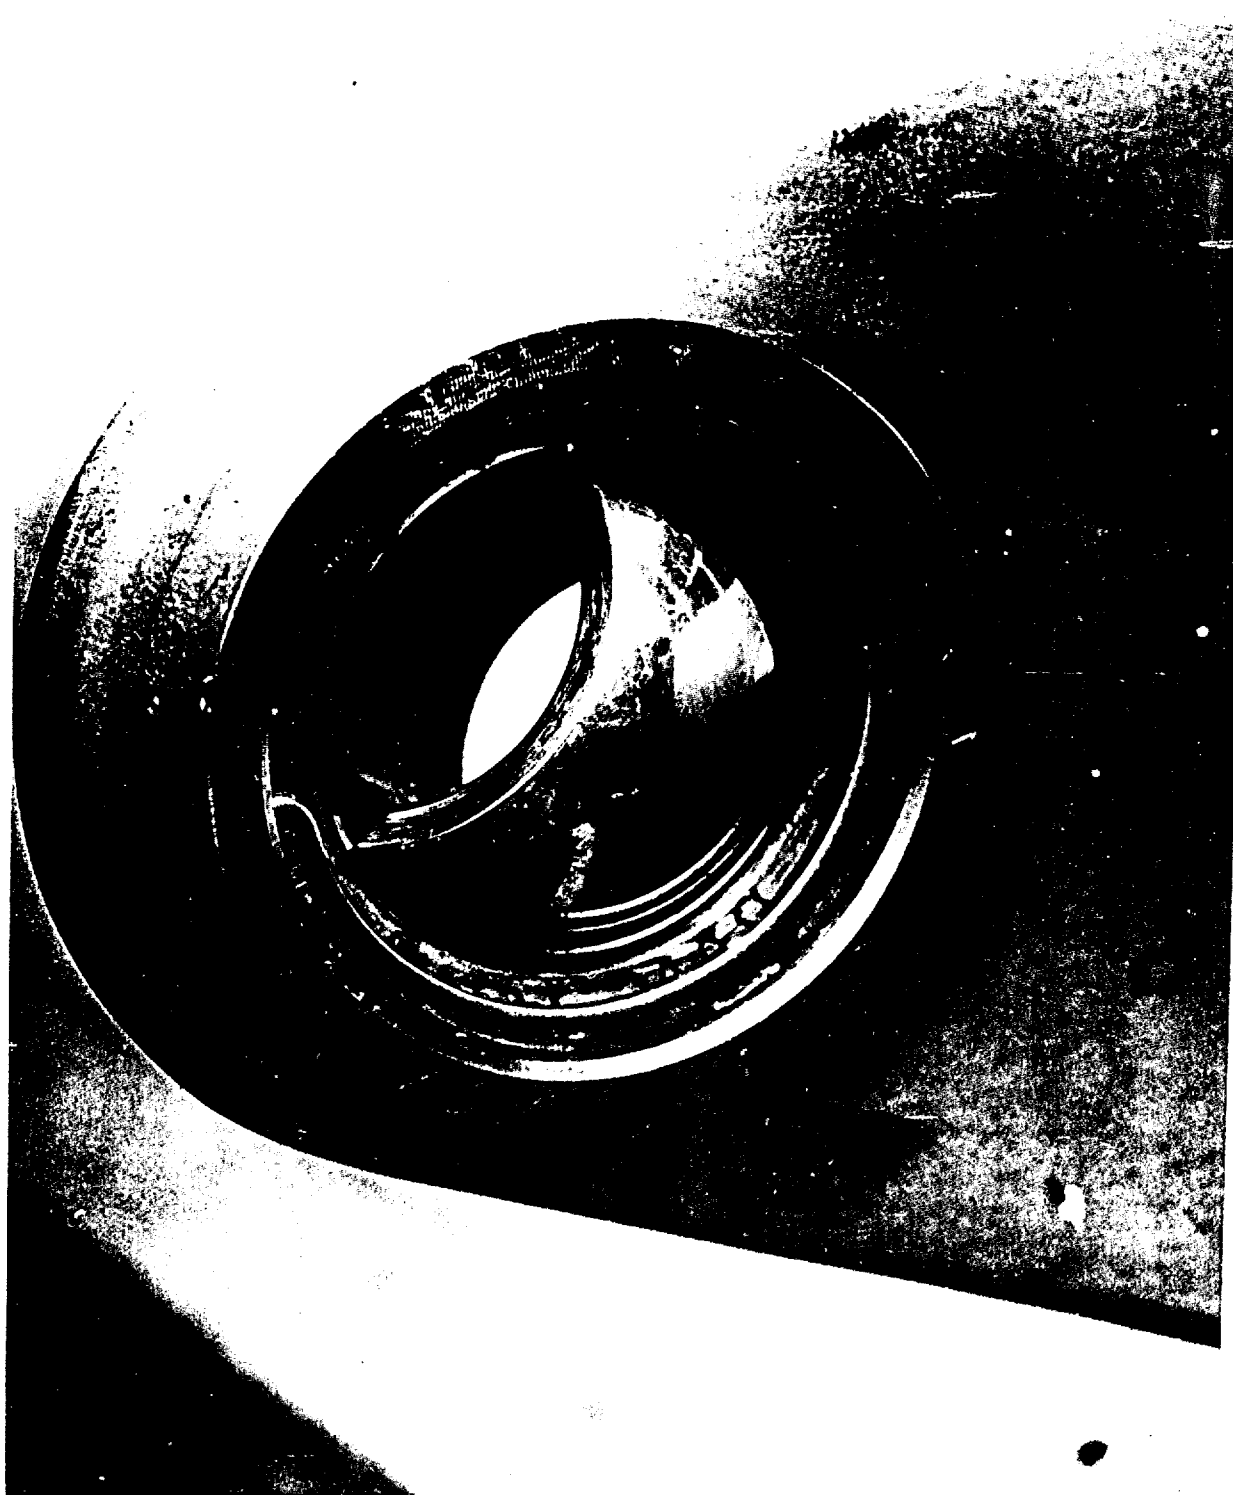
FIGURE 14 - Forward Engine Mount From RJ43-MA-E10011-1 Showing Rust on Bearing Retaining Ring Which Occurred During the Accelerated Storage Phase of the RJ43-MA-11 Phase II Long-Term Storage Test.

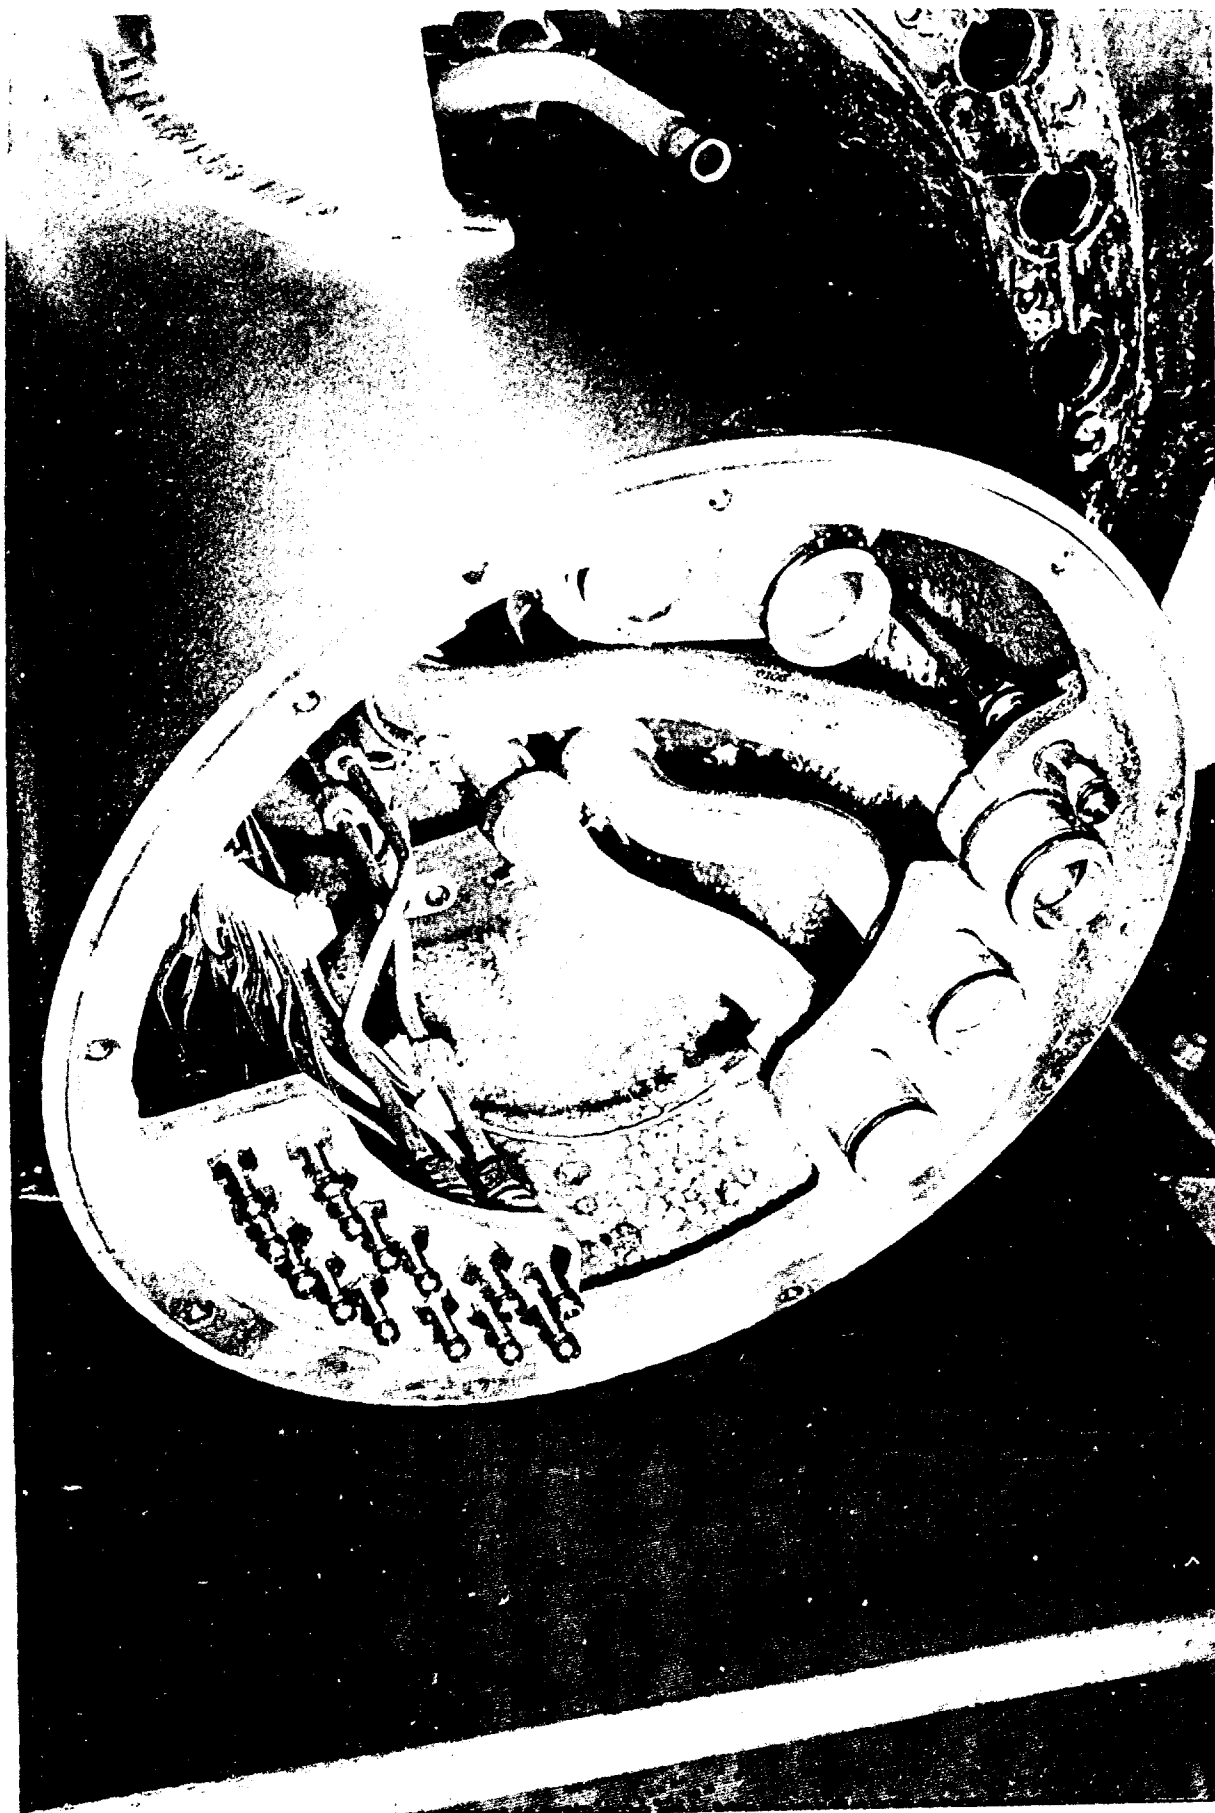
FIGURE 19 - Aft Innerbody Assembly From RJ43-MA-11 Engine Serial MA-E10011-1 Showing Magnesium Corrosion at Junctions with Steel Details, Rusted Spirolox Rings, and Corrosion of Aluminum Fuel Lines Which Occurred During the Accelerated Storage Phase of the RJ43-MA-11 Phase II Long-Term Storage Test.

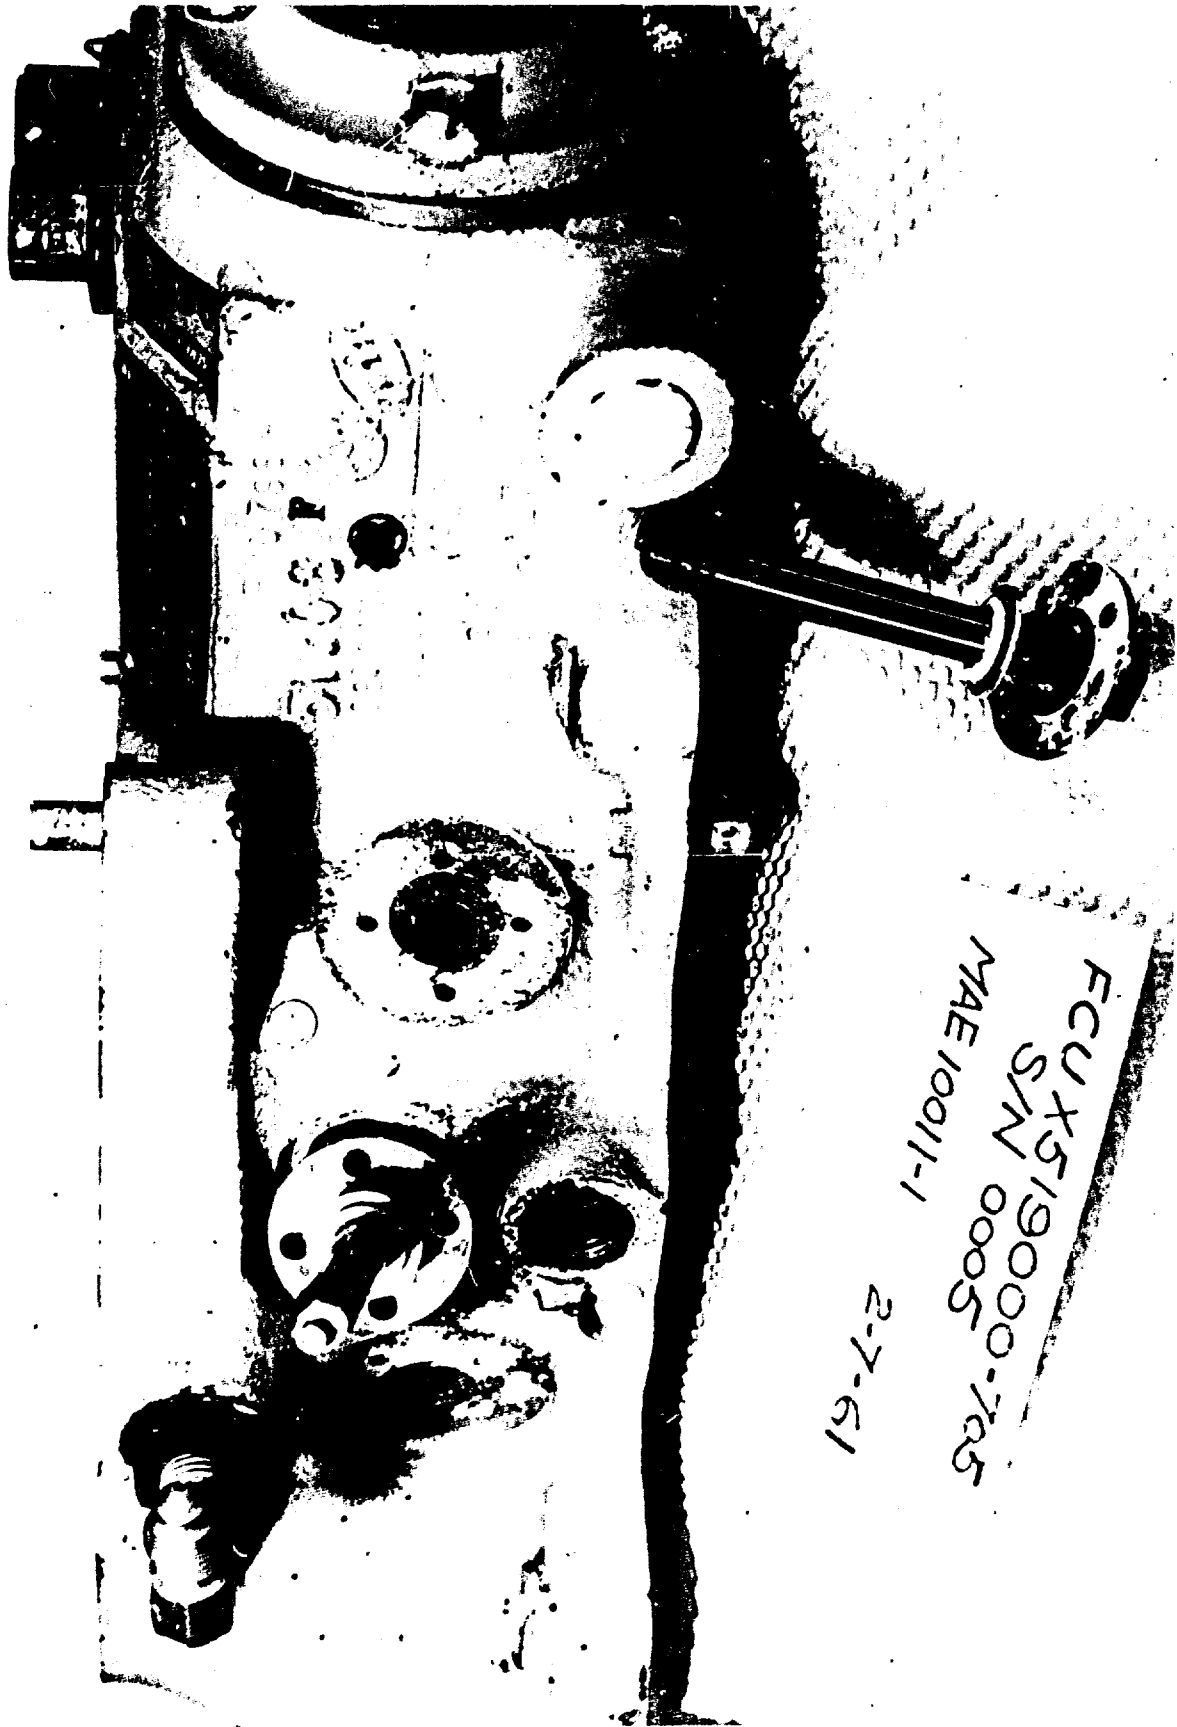
FIGURE 26 - Mach Sensor-Shock Position Control Assembly From RJ43-MA-11 Engine Serial MA-E10011-1
Showing Corrosion of Cam Retainers and Stops Which Occurred During the Accelerated Storage
Phase of the RJ43-MA-11 Phase II Long-Term Storage Test.

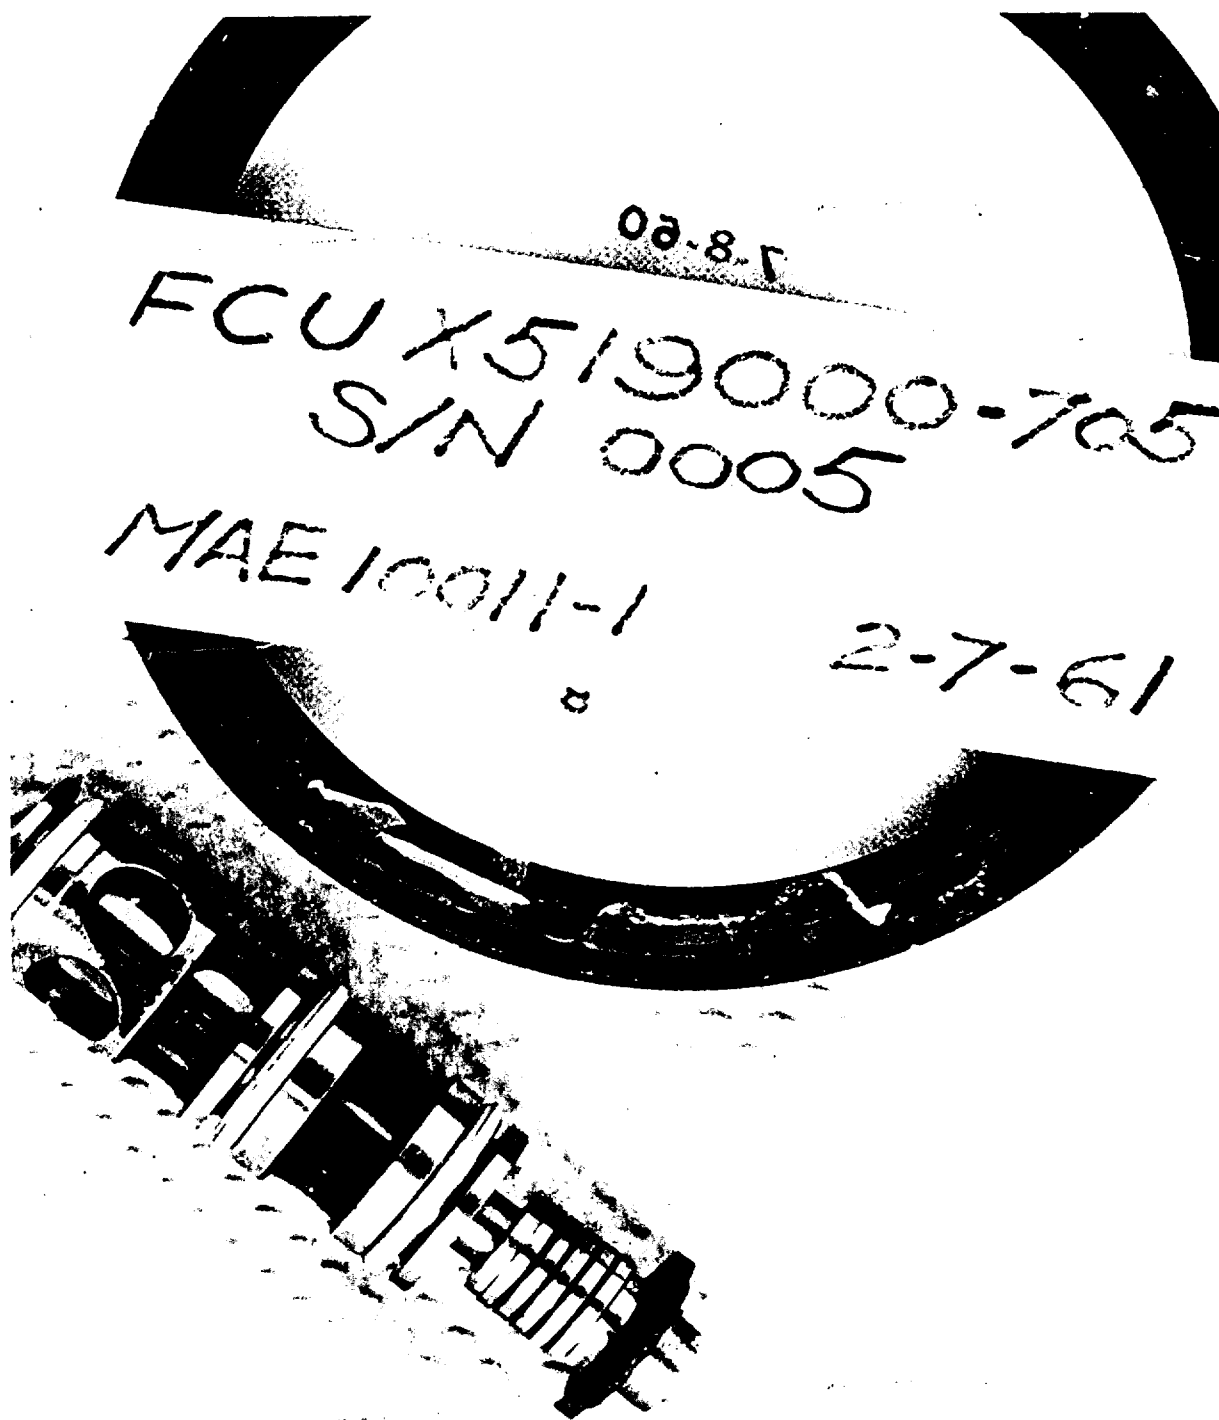
FIGURE 28 - Mach Sensor Valve-Sleeve Assembly and Diaphragm from RJ43-MA-11 Engine Serial MA-E10011-1 Showing Corrosion and Diaphragm Disintegration Which Occurred During the Accelerated Storage Phase of the RJ43-MA-11 Phase II Long-Term Storage Test.

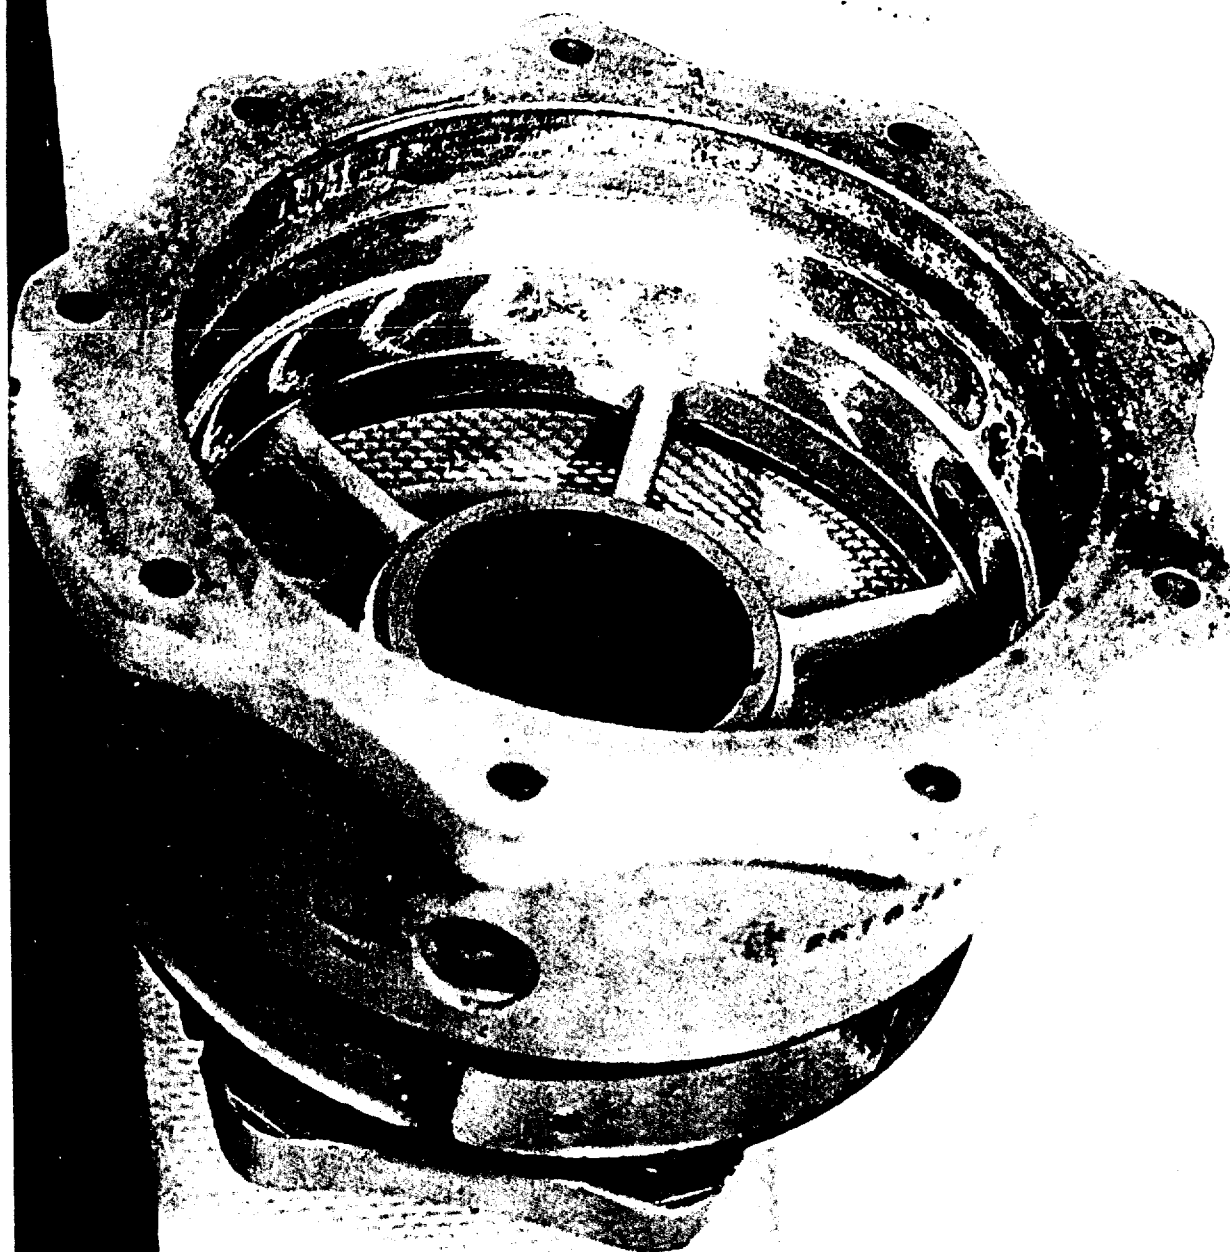
FIGURE 37 - Turbine Housing Assembly From RJ43-MA-11 Engine Serial MA-E10011-1 Showing Corrosion Deposits Where Water had been Trapped Inside Housing During the Accelerated Storage Phase of the RJ43-MA-11 Phase II Long-Term Storage Test.

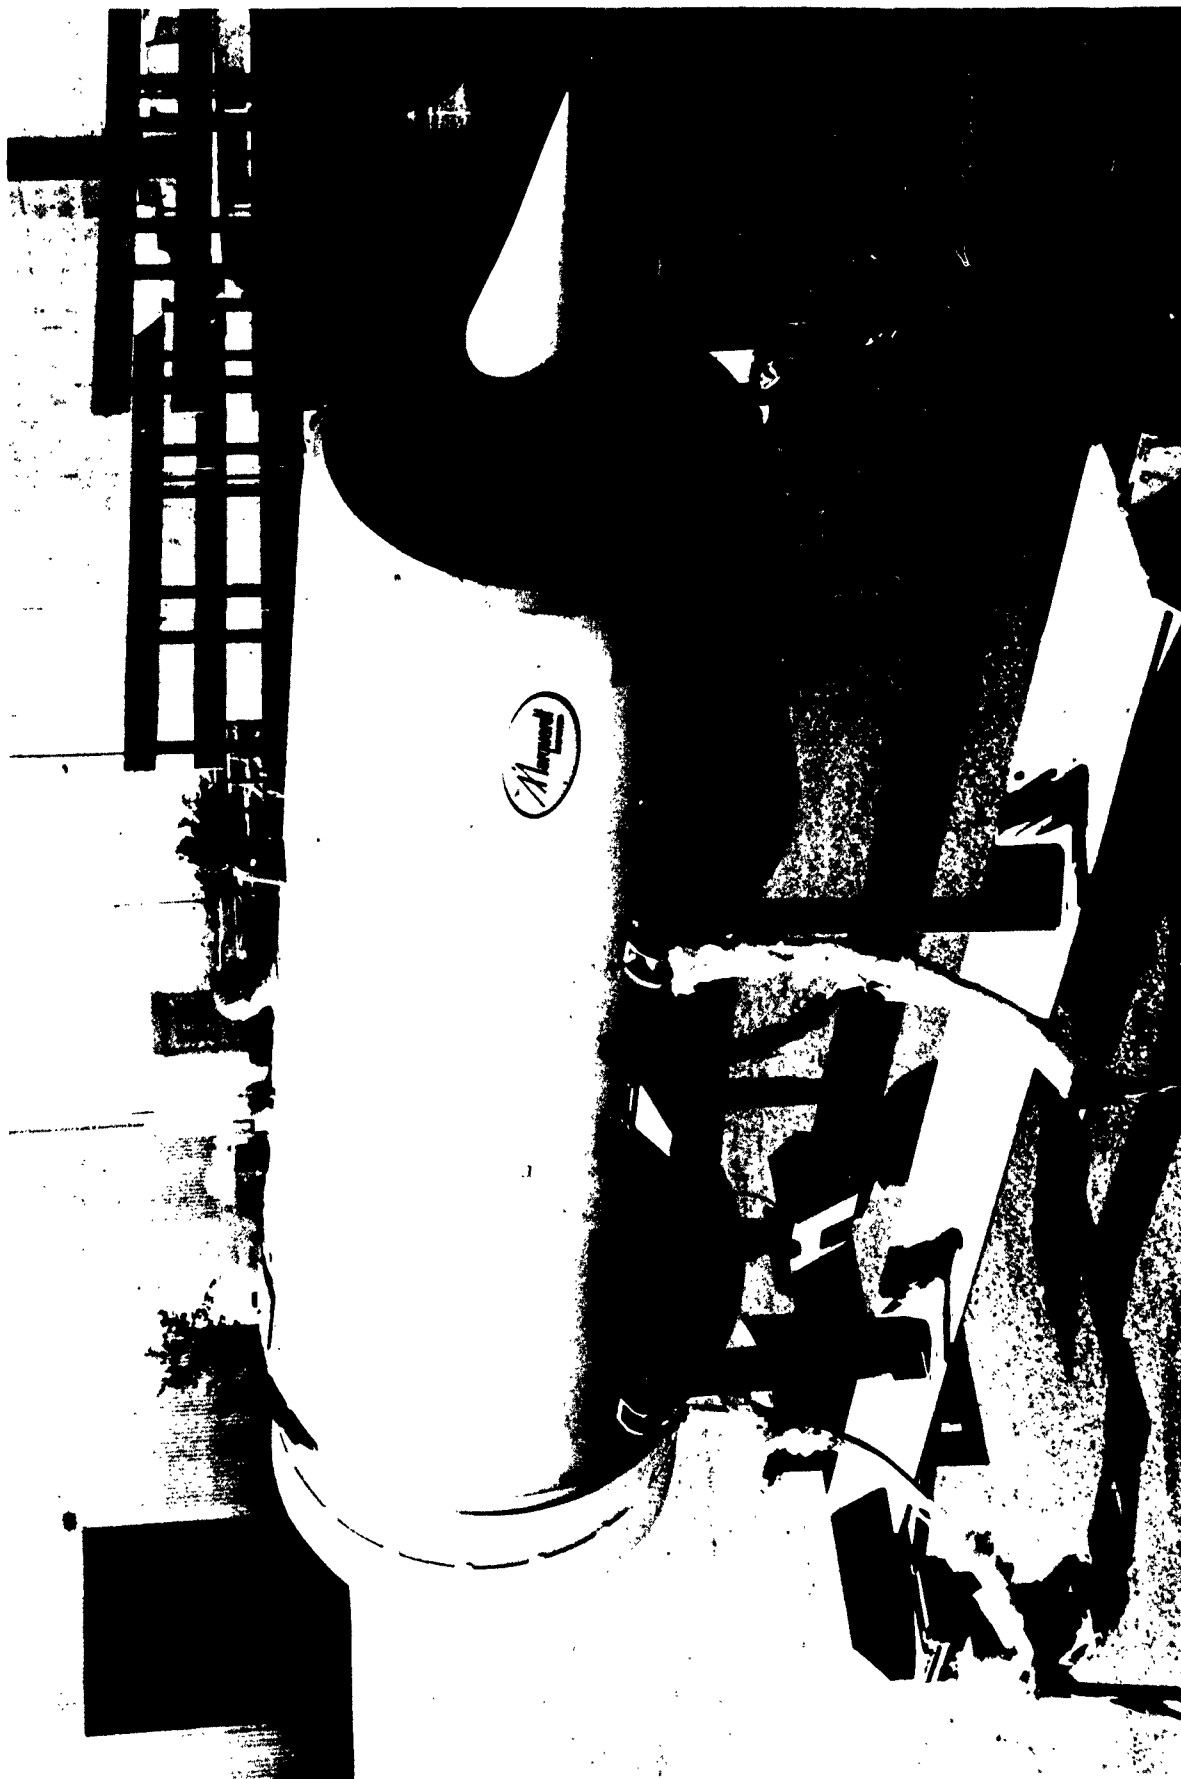
FIGURE 49 - RJ43-MA-11 Engine Serial MA-E10011-2 Main Structure Following Ignition Demonstration Burn Run Conducted After Two-Years of Ready-Storage.
